Colonial Charles HOA-FY22-Revision 1

Waldorf, MD

PM+ Level I Full Reserve Study

June 16, 2022

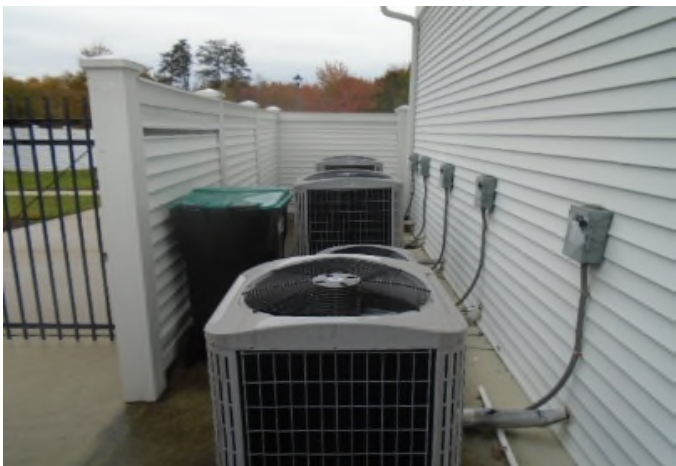
Life of HVAC equipment is dependent on proper servicing at established frequencies. Spot repairs can extend useful life; however, replacement will eventually be needed.

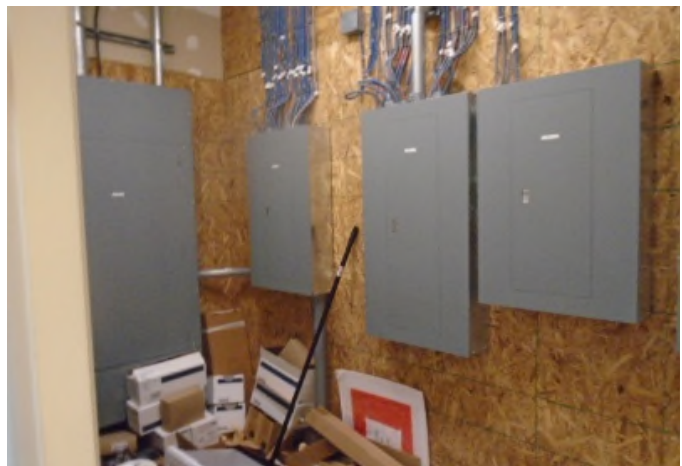
Reserves provide for electrical panels, wiring and other electrical systems to be repaired/replaced as needed.

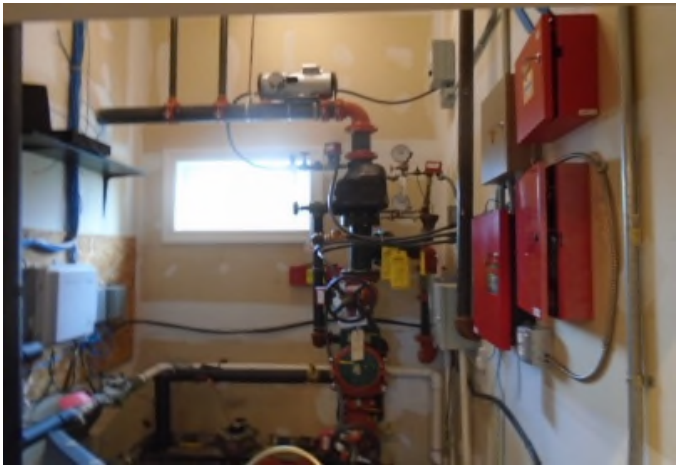
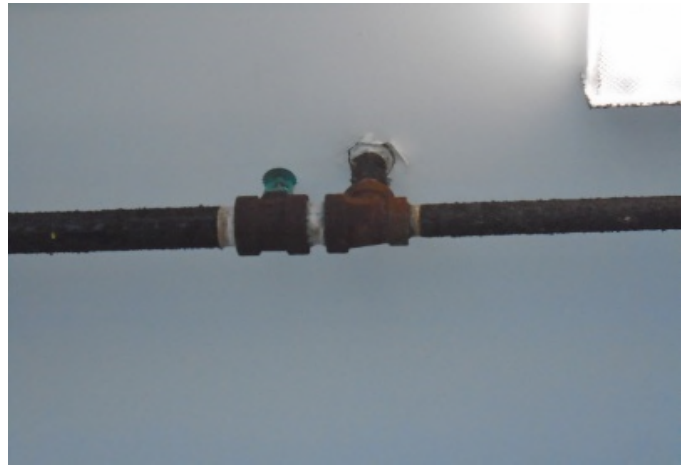
Fire alarm and sprinkler systems need upgrading when replacement parts are difficult to obtain or system deterioration jeopardizes effectiveness.

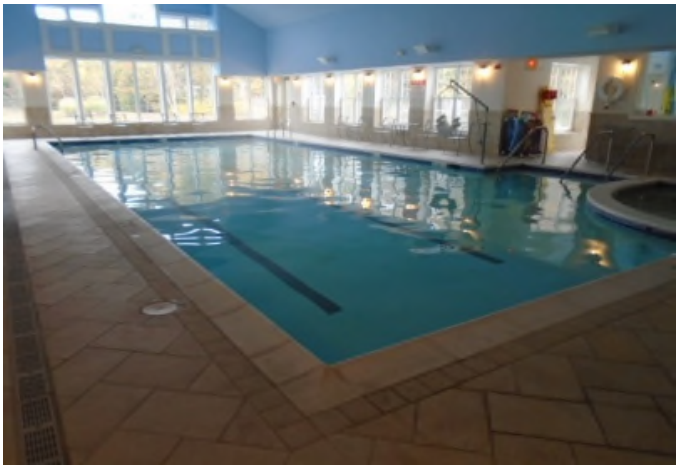
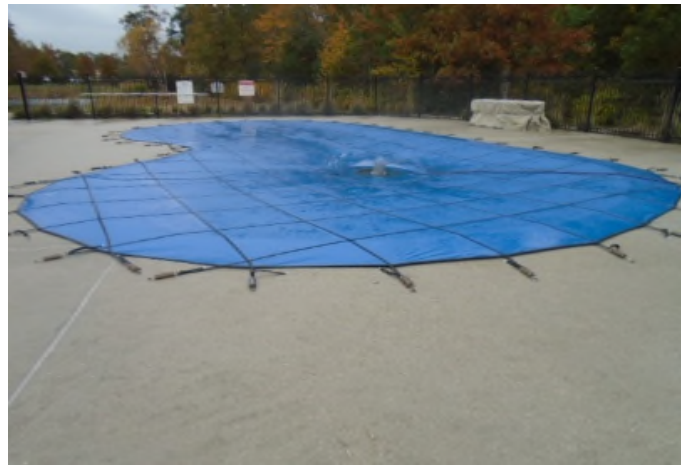
Association is responsible for indoor pool (left photo), and outdoor pool (right photo). Repair/replacement of dehumidifier, space heater, furniture, pool cover, concrete decks, fencing, and other systems are included in the reserves.

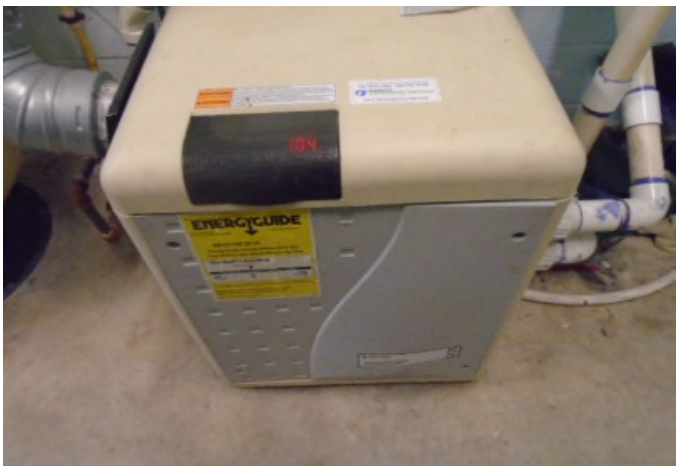
Pool heater for indoor spa (second pool heater for indoor pool not pictured). Reserves provide for replacement as needed.

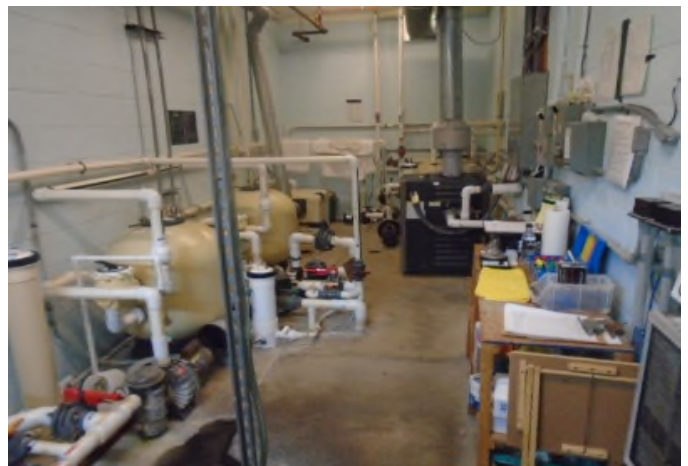
Pool filters, water supply/return piping, chemical equipment and other system components will need repair/replacement when problems occur.

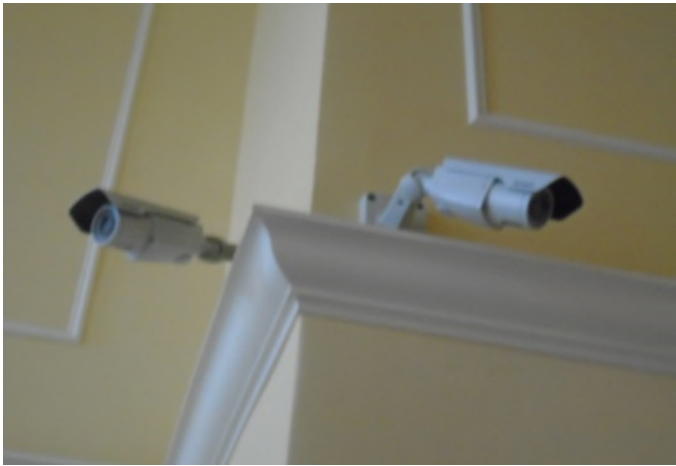
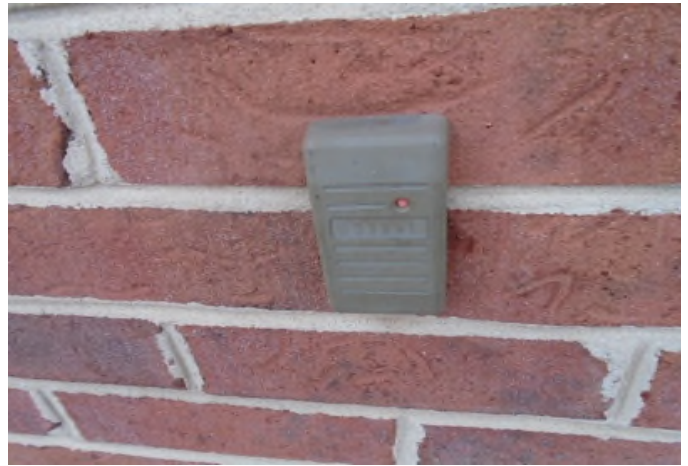
Security system (left photo), and keyless entry system (right photo). Repair/replacement will be needed when parts are no longer available or system reliability is compromised.

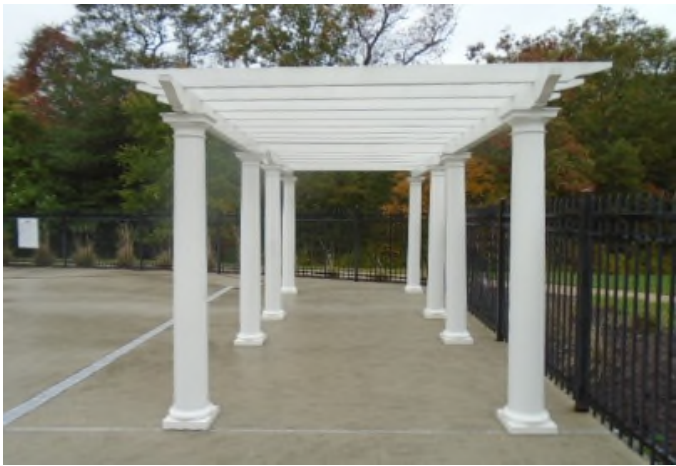
Reserves provide for replacement of vinyl arbor at the end of useful life.

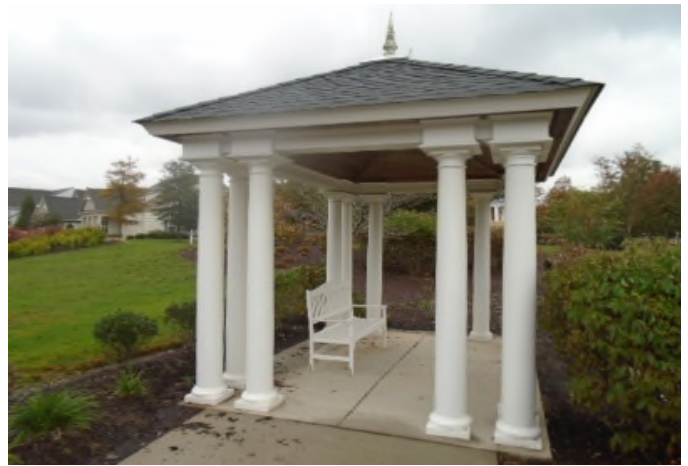
Reserve allows only for the gazebo roof to be replaced. We assume spot repairs will be done to extend useful life of the structure.

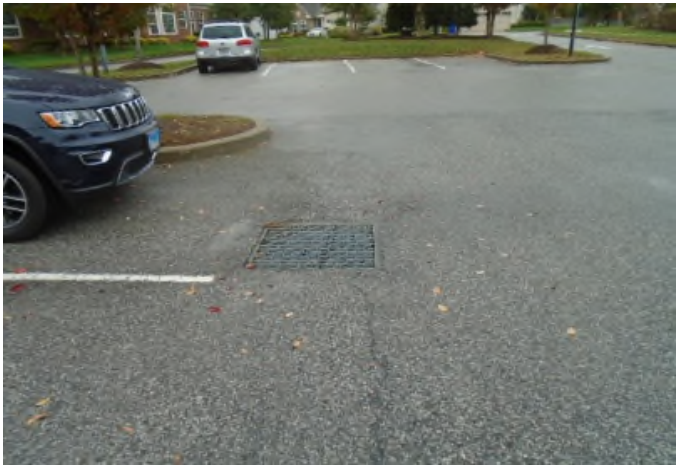
Asphalt pavement parking lot at The Clubhouse is in good condition. See our recommendations in the comments section for proper care of asphalt pavements.

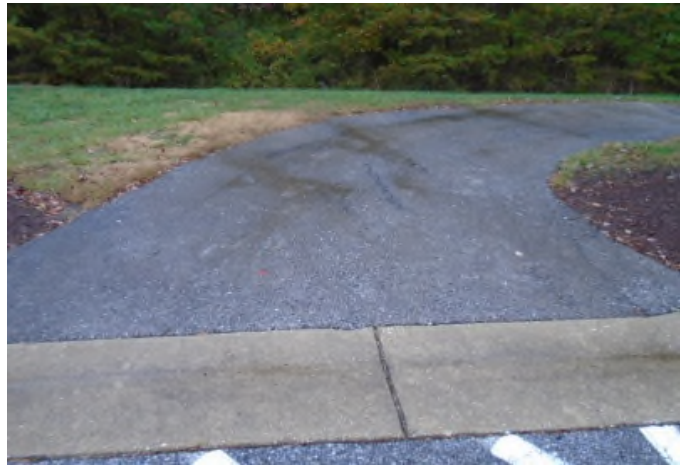
Reserve budgets for repair/replacement of association owned asphalt walking trails.

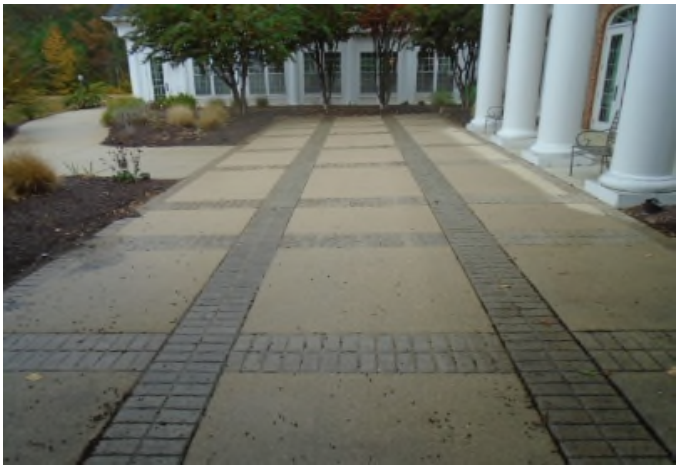
Association patios, sidewalks, curbs, gutters, and other concrete surfaces can be kept in good repair with spot repairs as needed.

CONCRETE/PAVERS	As needed repairs.

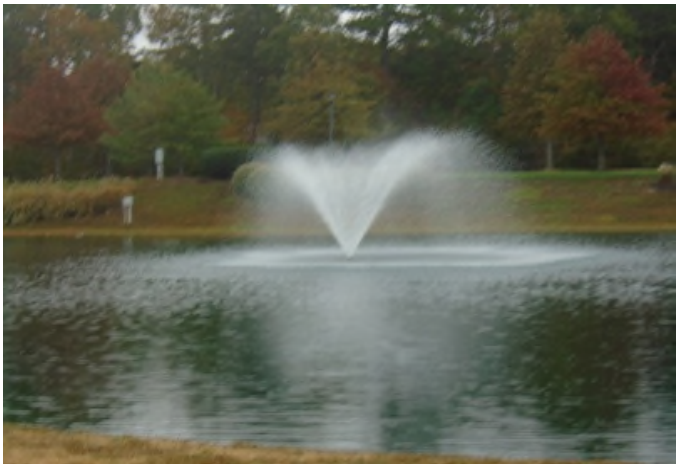
Spray fountain installed in pond. Reserve provides for replacement at end of life and power unit as needed.

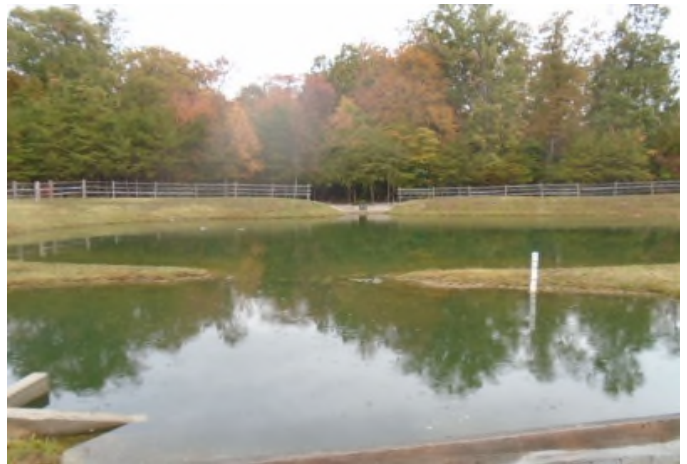
Water retention ponds periodically need dredging, erosion control, spillway maintenance and other repairs. See comments section for additional information.

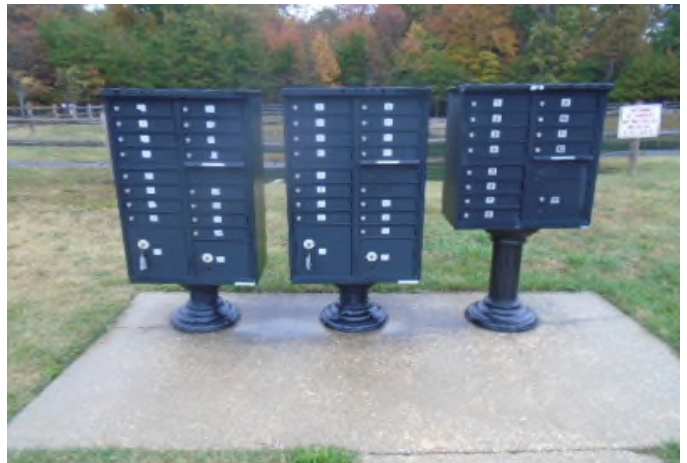
Mailbox replacement will be needed as doors, locks, hinges and other failures occur.
