Colonial Charles HOA-FY22-Revision 1

Waldorf, MD

PM+ Level I Full Reserve Study

June 16, 2022

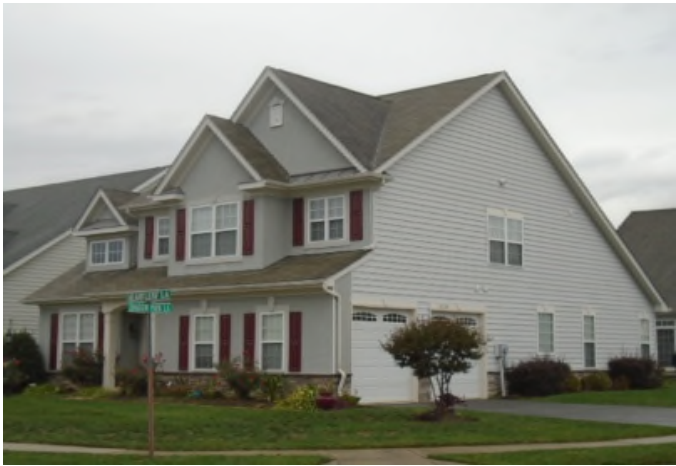
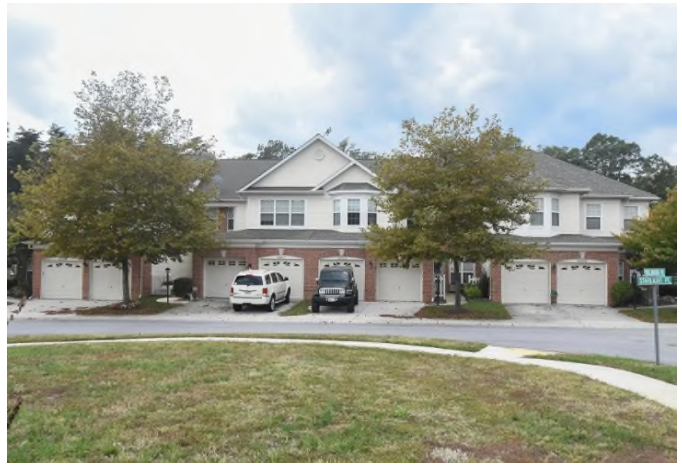
Colonial Charles is a 240-unit adult age restricted housing community located in Waldorf, Maryland. Photograph on left is typical of the housing style for the single family homes; photo on right of the villa style homes. Roofing, gutters, downspouts, façade, windows, doors, fencing and all other exterior components of the home are each owner's responsibility.

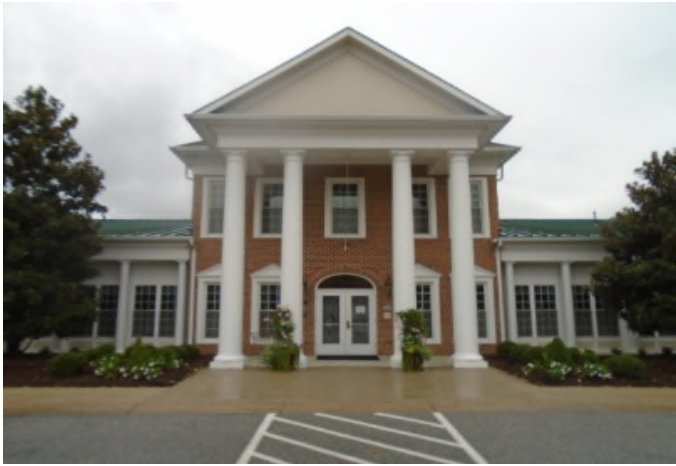
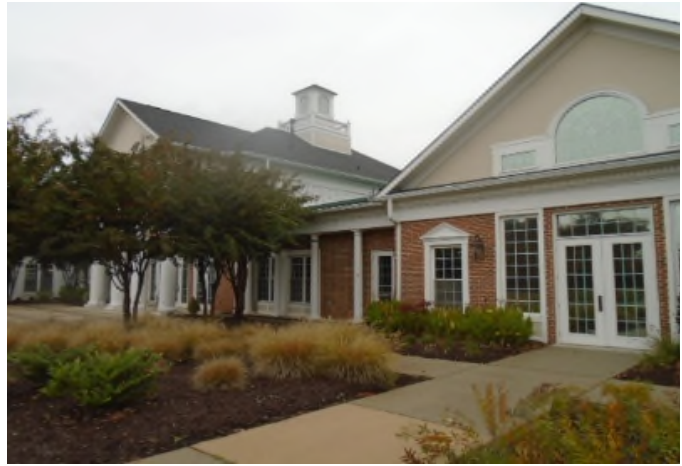
The clubhouse is association responsibility and serves as the community center, association management office, and bathhouse/pool(s). Interior and exterior components will need repair/replacement when they fail or reach the end of life. Reserves budget for this work.

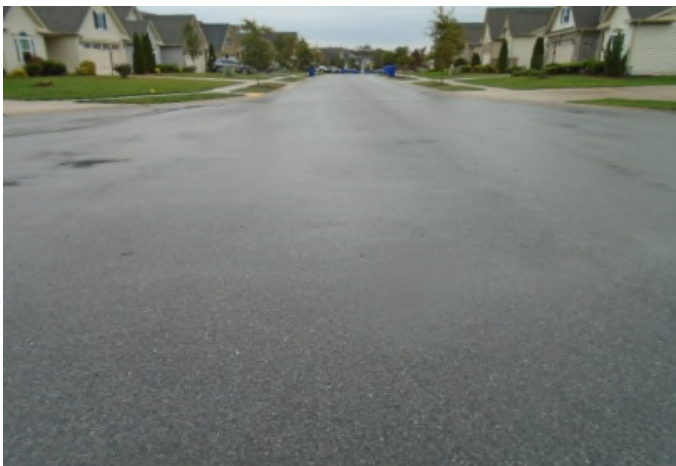
Community roadways are the responsibility of others and are not included in the reserves. Pavements that support the clubhouse are association responsibility.

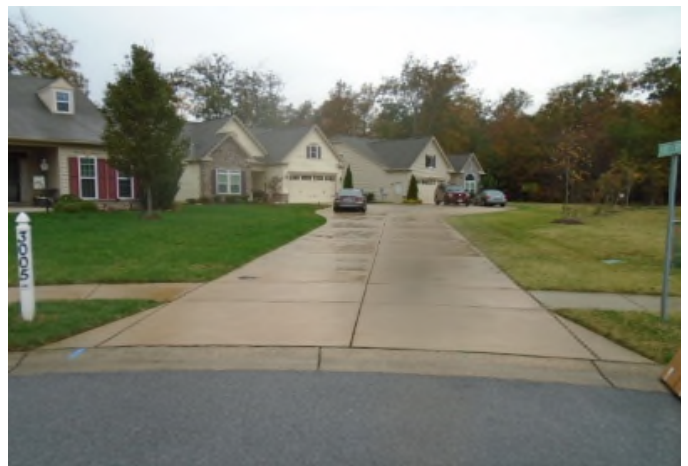
Concrete pipestems are the owner responsibility and are not included in the reserves.

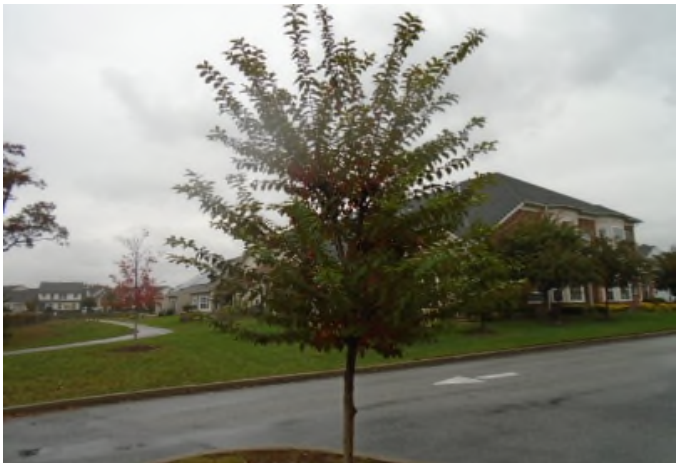
Replacement of dead or diseased trees and shrubbery is funded from the operating account and is not included in the reserves.

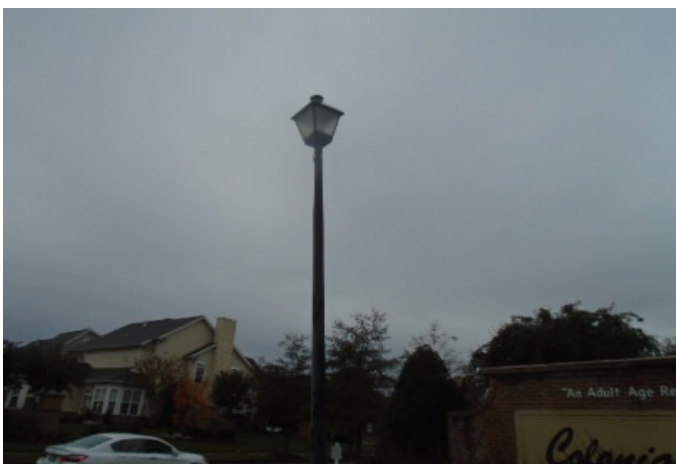
Street lights are the responsibility of SMECO and are not included in the reserves.

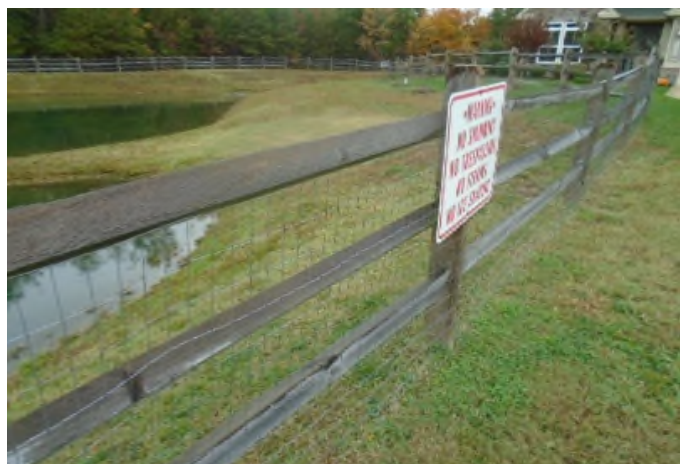
Signs and other components not identified as a separate reserve entries are also included in the reserves. Well maintained items enhance property appearance.
